Home Inspection Report

2003 Happy Trail Drive, Salt Lake City, UT 84075

Saturday, June 6, 2015

2015-101

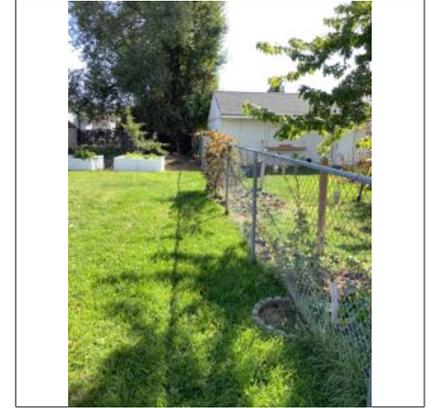
Vegetation growing through Chainlink fence, recommend removal, could cause problem in the future.

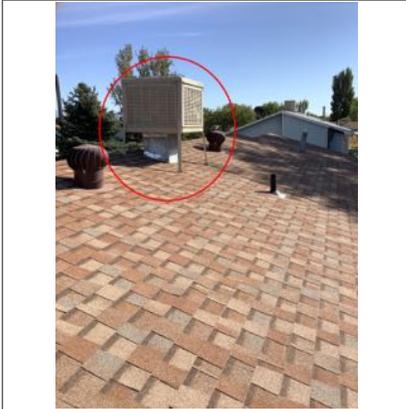
Evaporated cooler is not hooked up, recommend removal of evaporated cooler and evaluate roof by a licensed roof contractor. Evidence of leakage in attic from evaporated cooler.

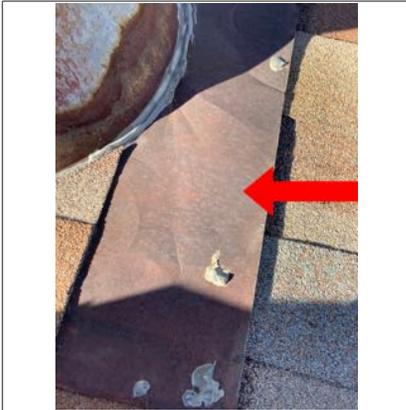
This is the only flashing showing signs of rust, recommend a licensed roofer repair/replace.

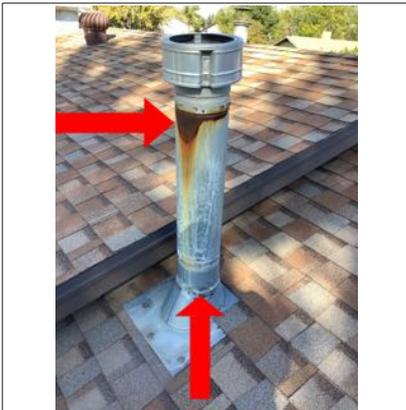
The HVAC vent is rusted. Recommend a licensed contractor repair or replace the vent.

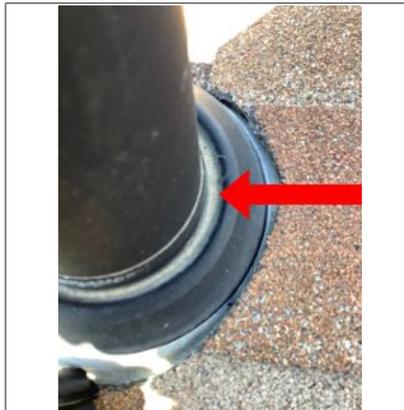
Boot push down causing water to pool and can cause it to deteriorate faster. Continue to monitor and repair as needed.

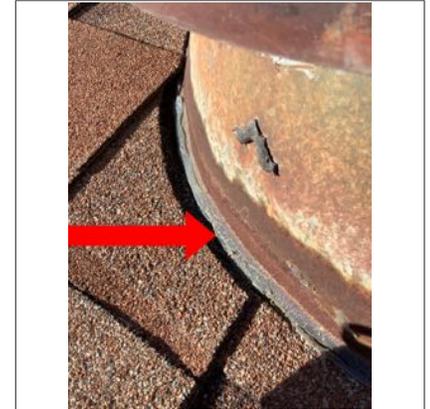
Chimney appeared to have been patched or tarred. Ongoing maintenance will be needed. Contact a licensed roofer to evaluate the chimney.

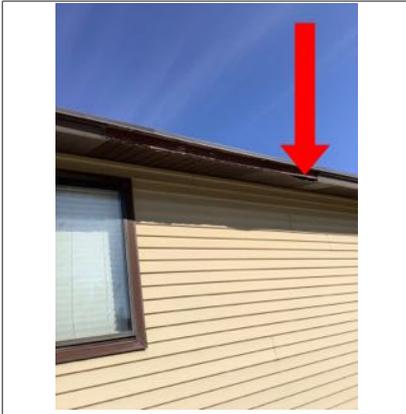
West side of house The soffit has areas of sagging, recommend a licensed contractor repair/re-secure.

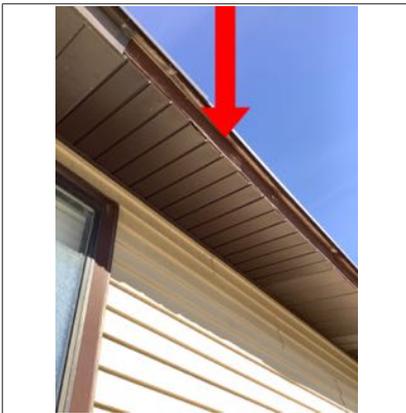
The fascia is missing recommend repair by a licensed contractor.

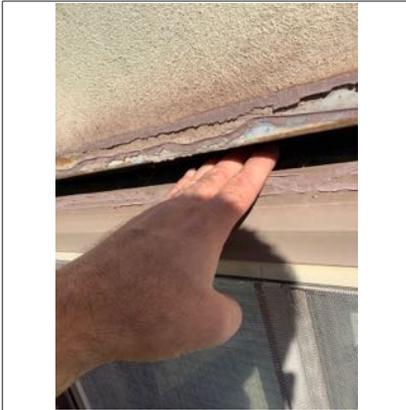
The flashing on all windows is missing/damaged, recommend proper installation by a qualified contractor.

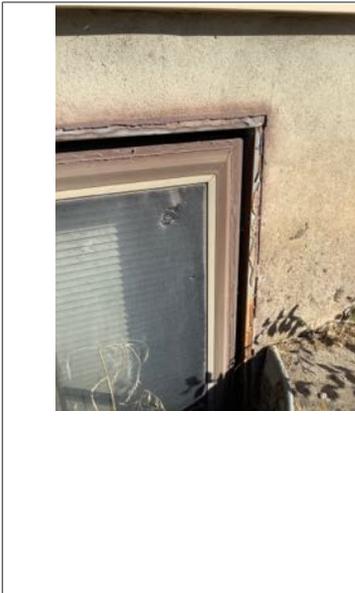
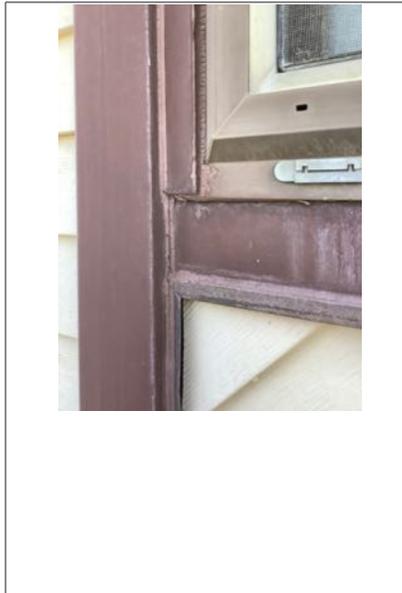
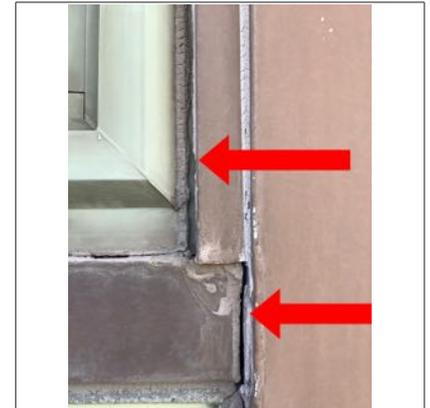
All caulking is dried and cracked, recommend removing and replacing the caulking. Recommend caulking around windows, doors, corners, utility penetrations.

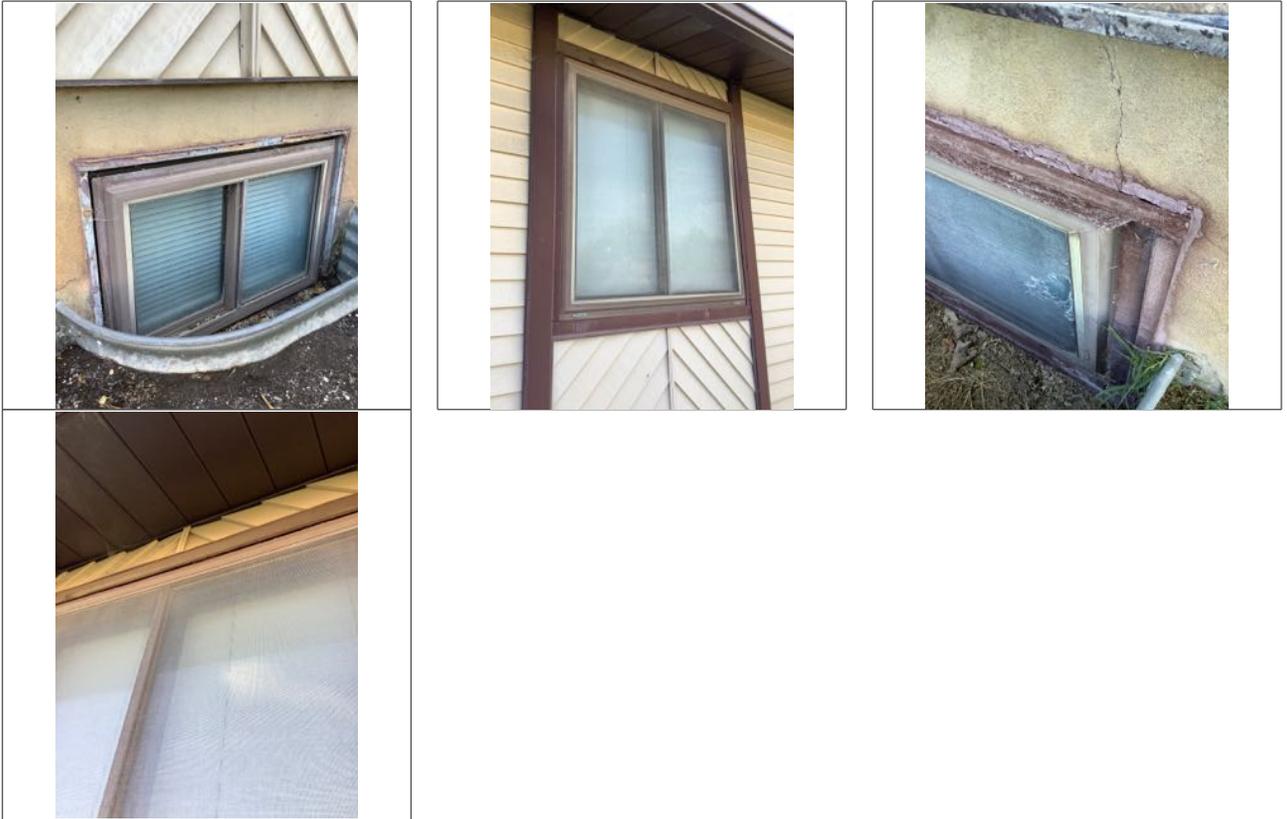
Some window screens are torn or damaged. Repair as needed.

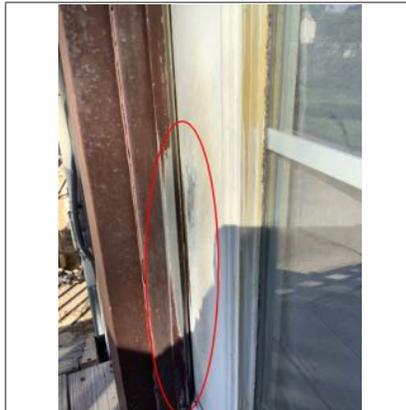
Rear door damaged, recommend repair/replacing.

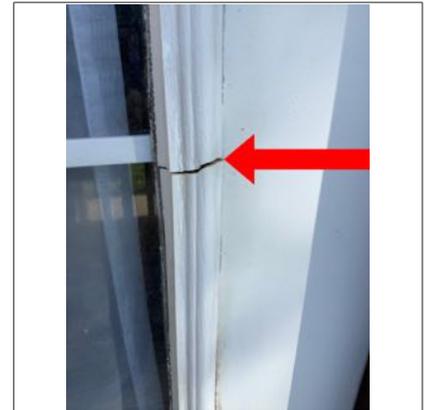
Cracked window trim back French doors

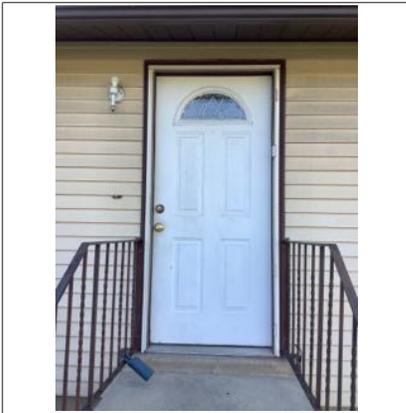
The entry door is door is weathered, recommend paint/stain to protect from further damage.

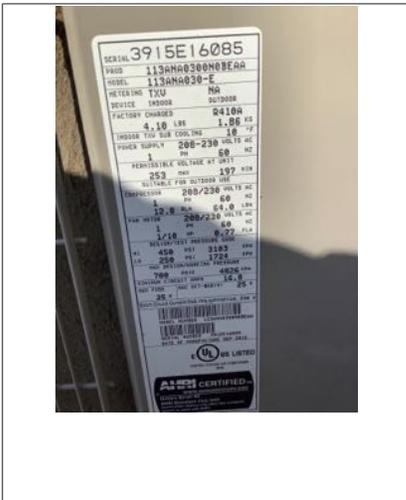
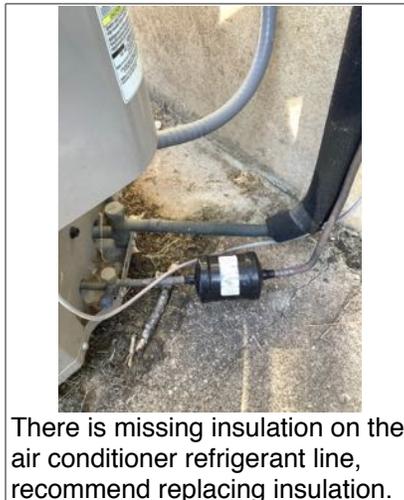
There is missing insulation on the air conditioner refrigerant line, recommend replacing insulation.

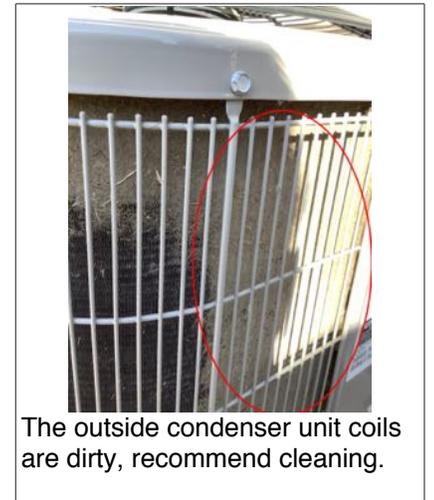
The outside condenser unit coils are dirty, recommend cleaning.

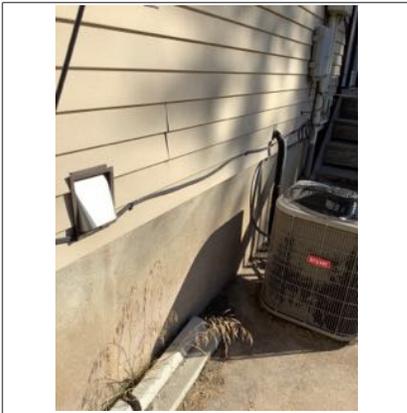
Dryer vent recommended to not be closer than 6 feet to the AC unit. Can cause hot air and lint to affect the AC's effectiveness.

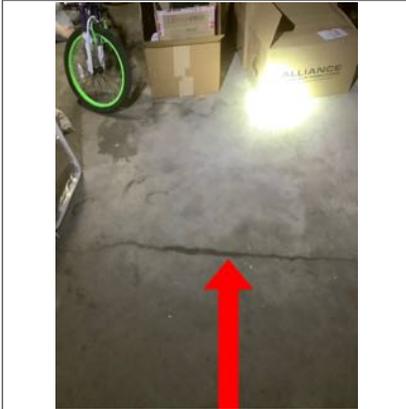
The garage floor has typical cracks. Recommend sealing with a product like Sikaflex. Could not inspect entire floor due to obstructions.

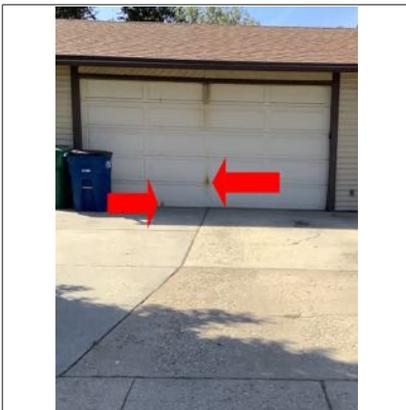
The garage door was rusted and had minor wear but was operable. Repair the damage door as needed.

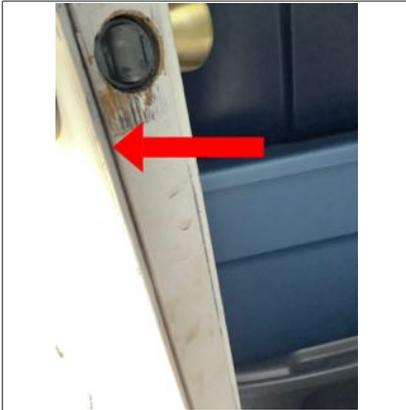
Door needs replacing, the door is delaminating and doorknob is broken and cannot secure premises

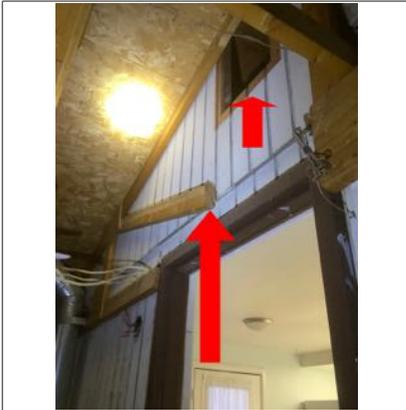
Improper firewall, between garage and house, safety hazard. The webbing on the truss has been damaged, Recommend licensed Roofer to evaluate.

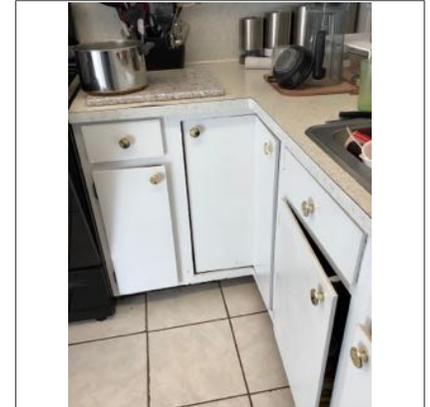
Cabinet door hinges needs adjustment/replace

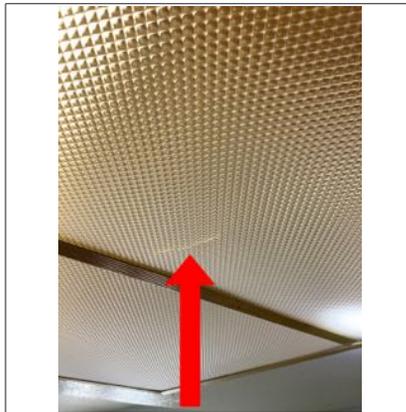
Cracks in lighting covers

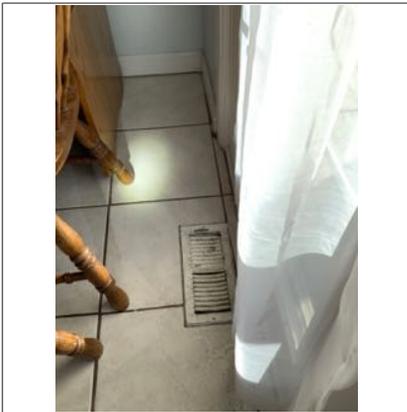
Both of the kitchen floor registers are rusted, stuck closed, not operable. Recommend replacement.

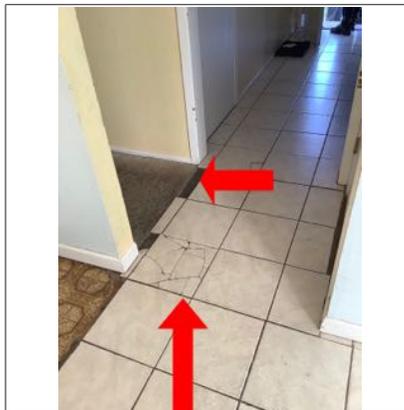
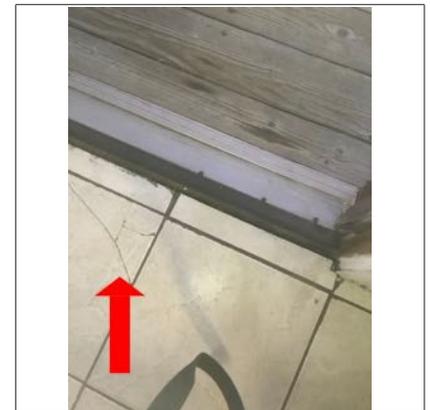
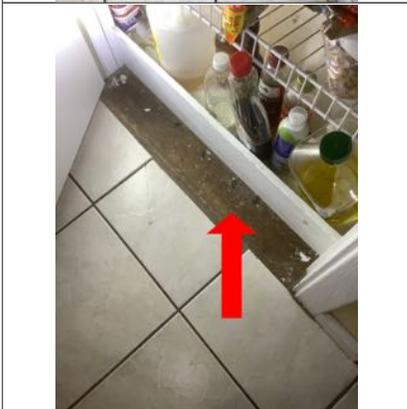
Comments The tile floor had some cracked tiles. Replace the tiles as needed. The floor covering in the kitchen is damaged, this is a trip hazard. Recommend repair/replace.

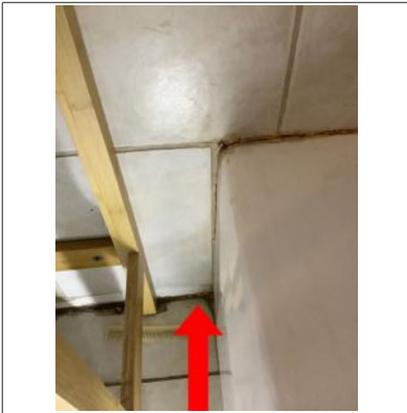
The caulk/grout has dried and cracked. Recommend replacing the caulk/grout where needed.

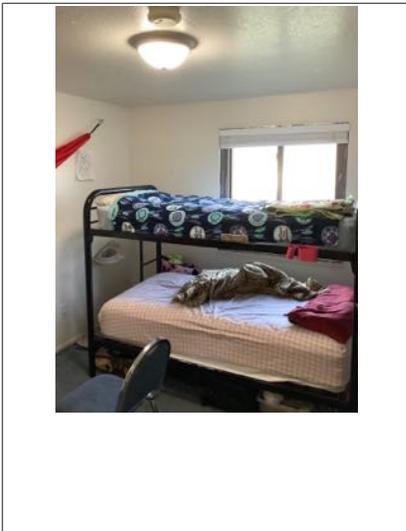
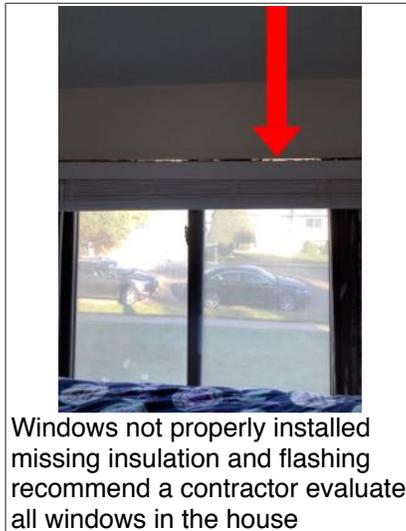
Windows not properly installed missing insulation and flashing recommend a contractor evaluate all windows in the house

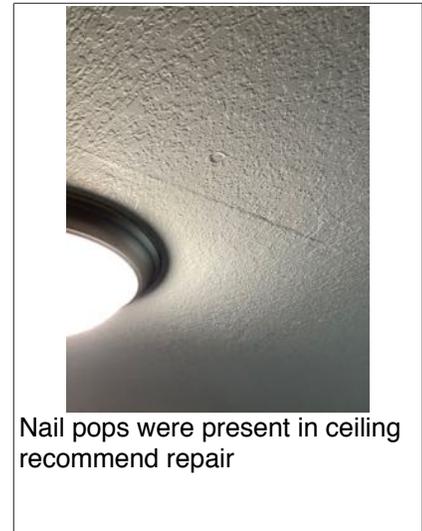
Nail pops were present in ceiling recommend repair

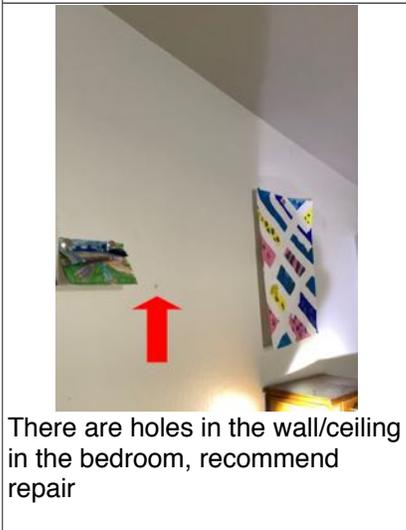
There are holes in the wall/ceiling in the bedroom, recommend repair

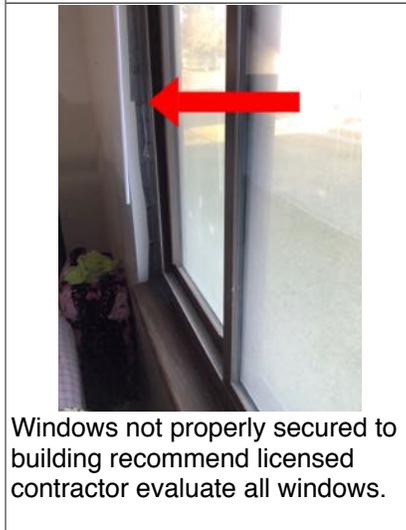
Windows not properly secured to building recommend licensed contractor evaluate all windows.

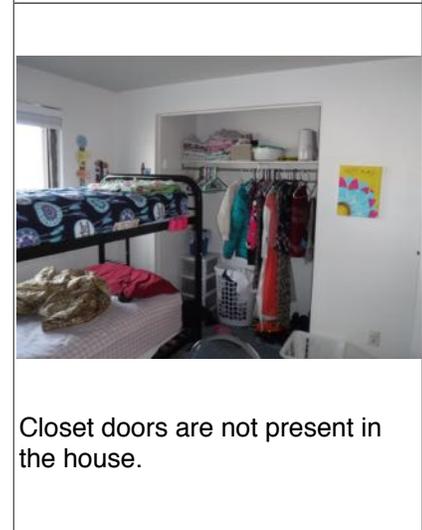
Closet doors are not present in the house.

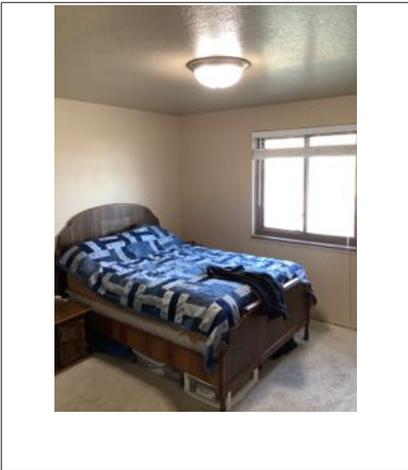
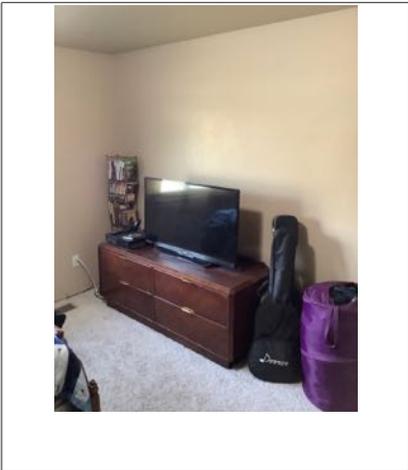
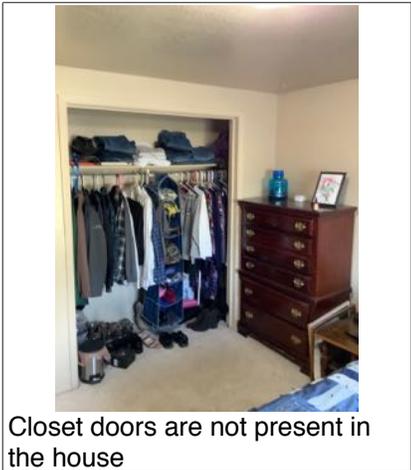
Closet doors are not present in the house

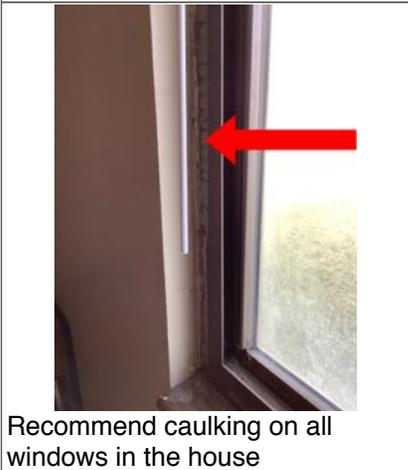
Recommend caulking on all windows in the house

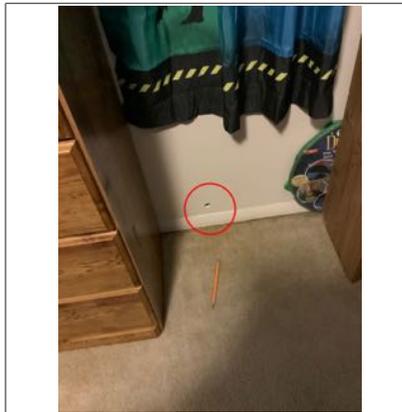
There are holes in in the wall/ceiling in the bedroom, recommend repair.

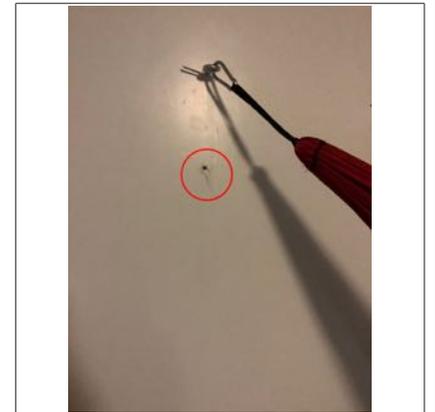
There are holes in in the wall/ceiling in the bedroom, recommend repair.

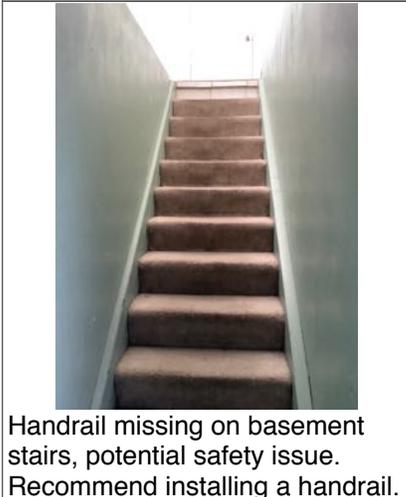
Handrail missing on basement stairs, potential safety issue. Recommend installing a handrail.

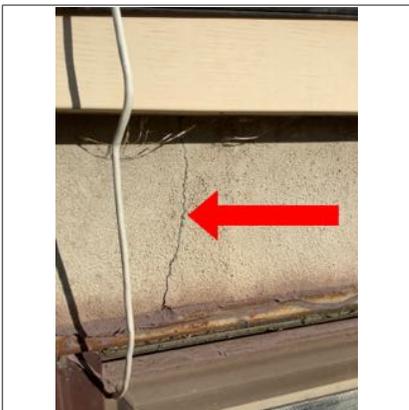
There are expected vertical cracks in the foundation. All cracks have a potential for leaking and for future potential movement which can not be predicted. Recommend monitoring and consulting a licensed foundation expert if any cracks start leaking or become active.

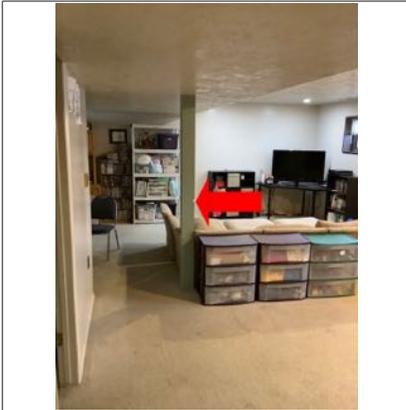
Columns are broken and/or cut in the basement, recommend qualified contractor repair/replace.

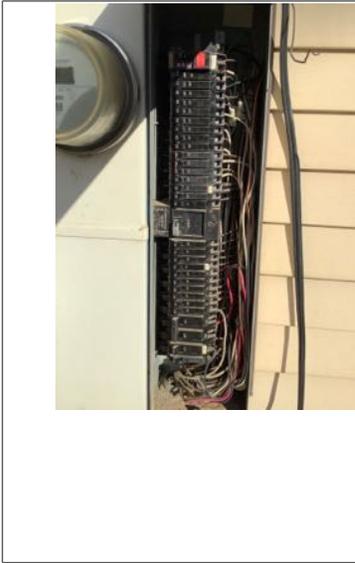
Double tapping is present. There are two breakers that currently are being double tapped. This is a safety hazard. Recommend a licensed electrician to evaluate.
