Home Inspection Report

2003 Happy Trail Drive, Salt Lake City, UT 84075

Saturday, June 6, 2015

2015-101

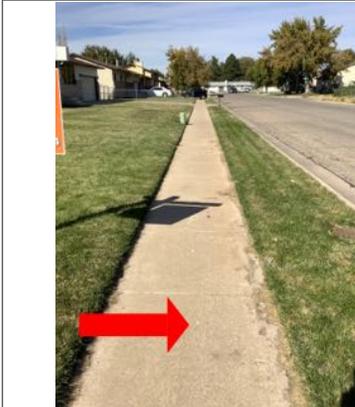
There is spalling on the service walks. Spalling can not be successfully patched. Monitor and replace the slabs as needed.

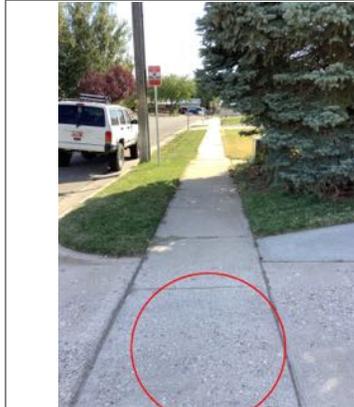
There is spalling on the service walks. Spalling can not be successfully patched. Monitor and replace the slabs as needed.

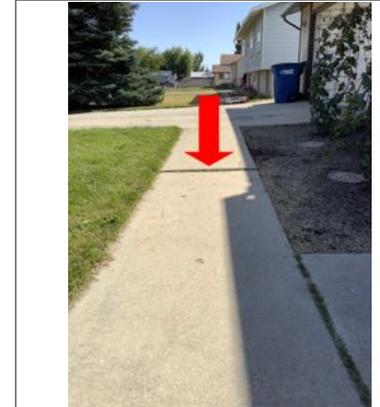
There are uneven slabs at the walkways which could be a tripping hazard. Recommend repair and/or replace.

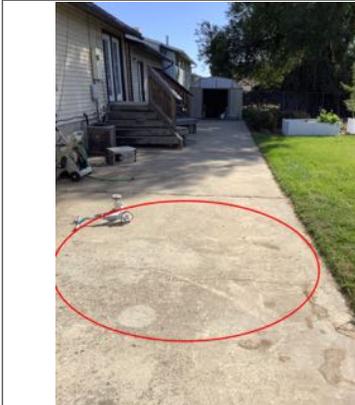
The walkway had some typical cracking/chipping, but is usable. Recommend sealing the cracks with a product like Sikaflex to help prevent additional damage.

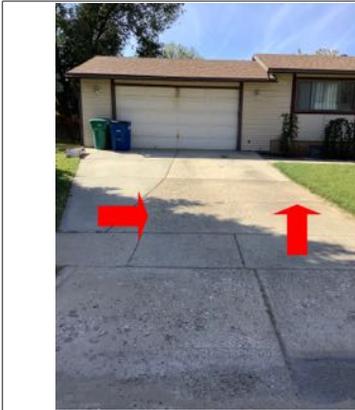
The driveway has areas of spalling. Spalling can not be successfully patched. Monitor and replace the slab as needed. The driveway has normal cracking. Recommend sealing the cracks with a product like Sikaflex to help prevent additional damage. The driveway has some settlement, but is usable. Recommend a licensed contractor repair as needed.

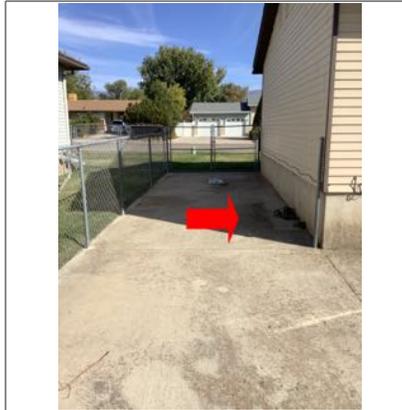
The RV pad has areas of spalling. Spalling can not be successfully patched. Monitor and replace the slab as needed.

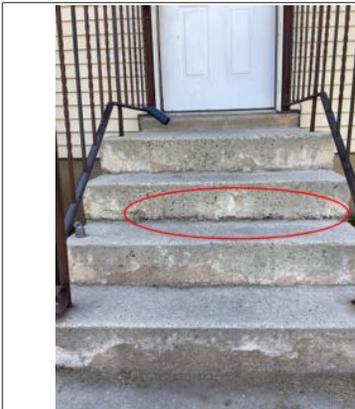
There is a crack at the steps. Recommend sealing the crack at the steps with a product like Sikaflex to help prevent additional damage to the concrete.

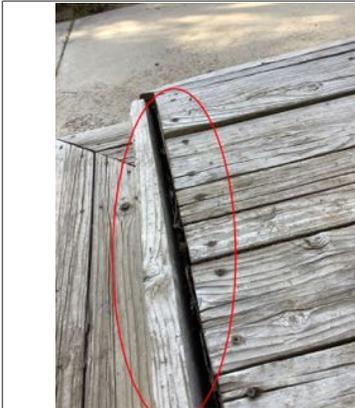
There are areas of rot on the deck. Rot will shorten the life of the deck. Recommend removing/treating the rotted areas. Replace any damaged wood as needed. Tripping hazard!

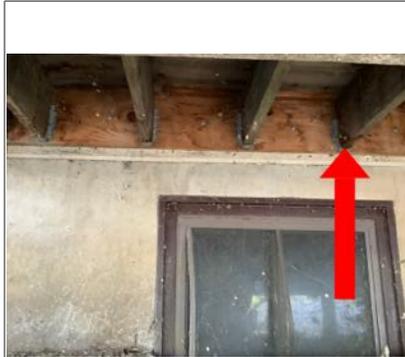
Rot will shorten the life of the deck. Recommend removing/treating the rotted areas. Replace any damaged wood as needed

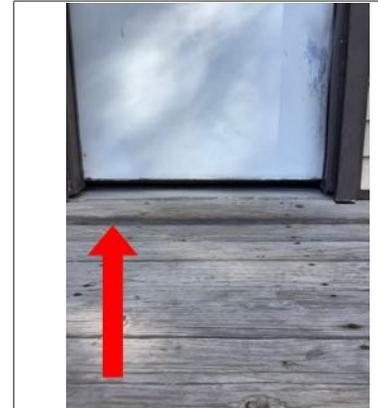
Tripping hazard.

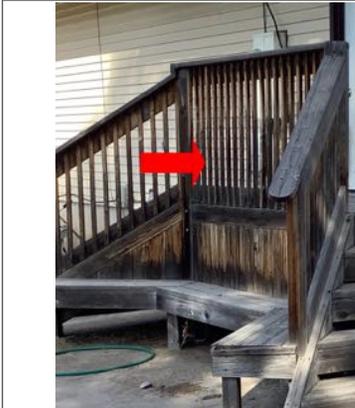
Recommend painting or treating wood on the deck to help protect it from continuous damage. There is organic type growth on the wood at the deck. Recommend a professional contractor treat/remove the growth.

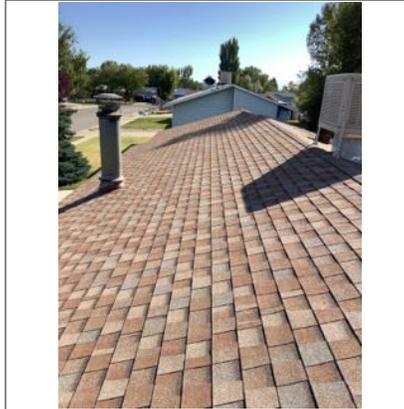
Evaporated cooler is not hooked up, recommend removal of evaporated cooler and evaluate roof by a licensed roof contractor. Evidence of leakage in attic from evaporated cooler.

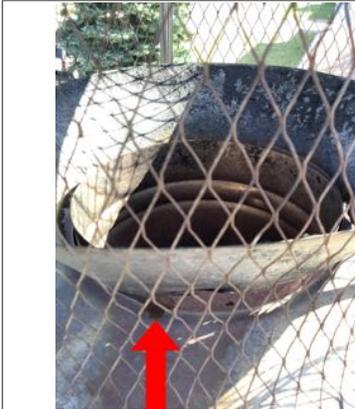
The chimney cap is rusted. Monitor and consult a licensed chimney sweep as needed.

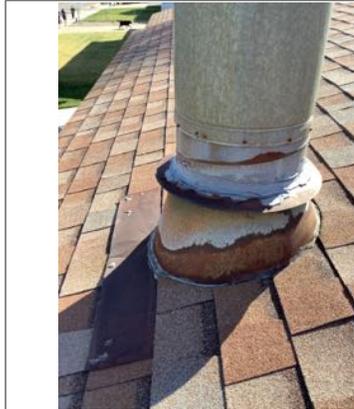
The base of chimney is rusted. Monitor and consult a licensed chimney sweep as needed.

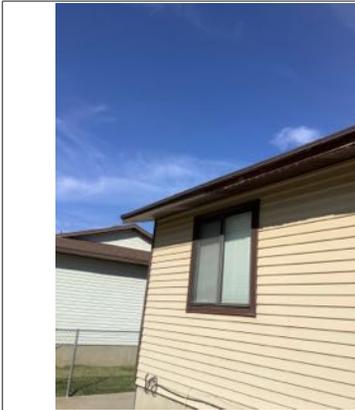
Gutters on only a portion of the house. Recommend a licensed roofer add gutters to properly direct water flow away from the house and the foundation.

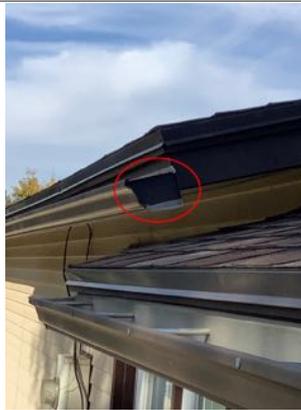
Gutters terminate on roof surfaces. This is a common practice, but will concentrate large amount of water on one location of asphalt shingles. This will allow more wear on one location. Recommend redirecting the water discharge to other gutters or to the ground.

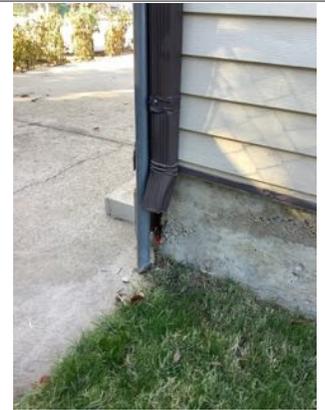
All the downspouts do not direct water far enough away from the house. Recommend adding downspout extensions to discharge away from the house. 5-6' extensions recommended. Southwest corner, southeast corner, Northeast corner.

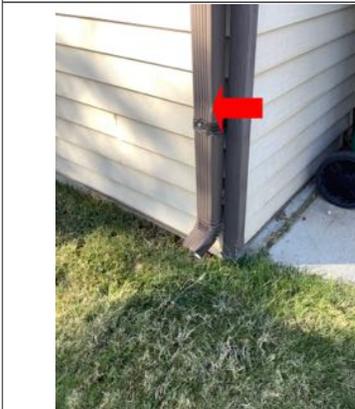
The gutter downspouts had some visible damage , recommend repair.

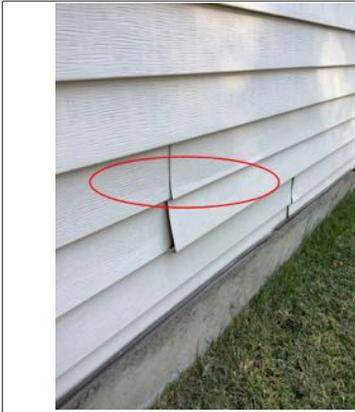
The siding had some damage, recommend a licensed contractor repair/replace damaged sections.

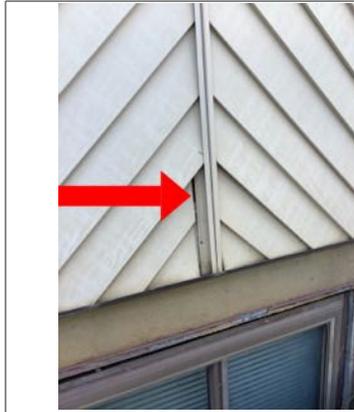
The siding had some damage, recommend a licensed contractor repair/replace damaged sections.

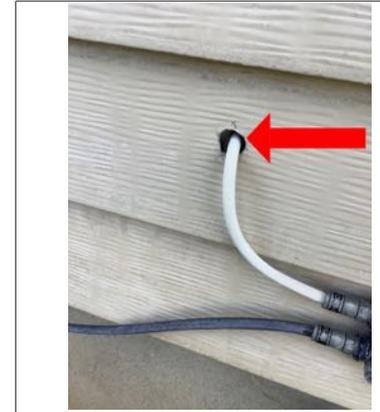
Grommet needed to keep out the elements, recommend replace

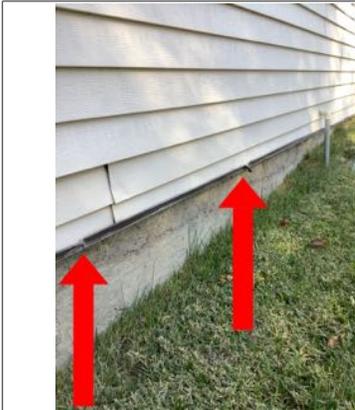
Recommend repair of damaged exterior trim by a licensed contractor.

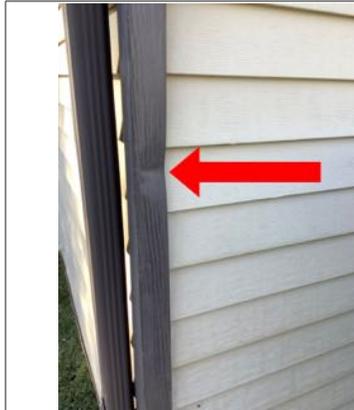
Recommend repair of damaged exterior trim by a licensed contractor.

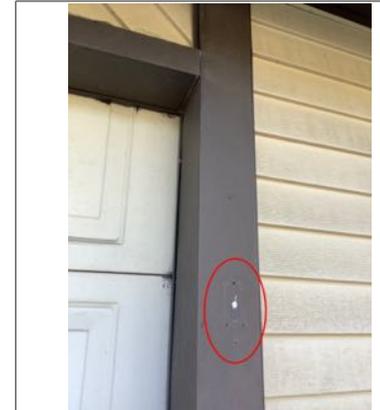
Seal holes in trim the keep the elements out.

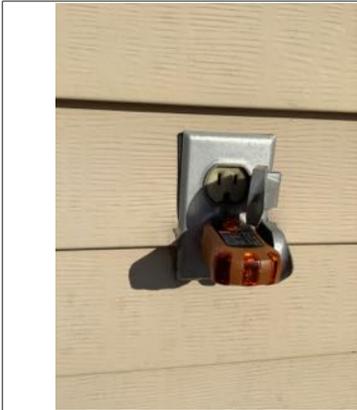
Receptacle not working .
Recommend a licensed electrician to evaluate.

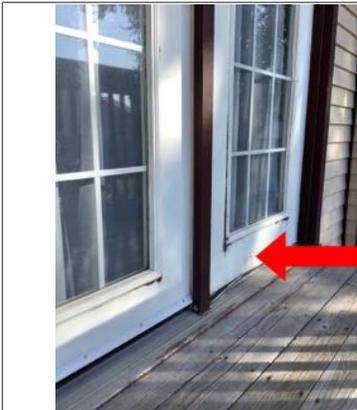
Rust present recommend monitoring and repair/replacing as needed.

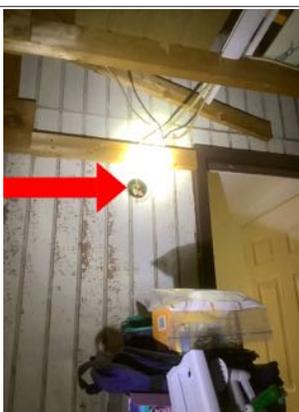
There is no cover plate. Electrical wire is exposed. Add cover plate.

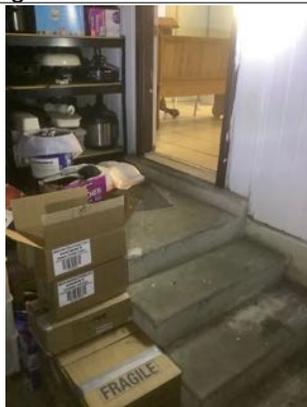
Obstruction of view, due to the home owners belongings in the garage.

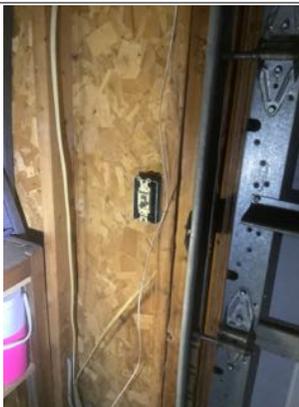
All cover plates are missing on the receptacles & switch plates in the garage , needs plates.

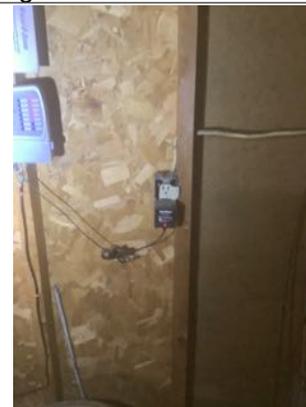
All cover plates are missing on the receptacles & switch plates in the garage , needs plates.

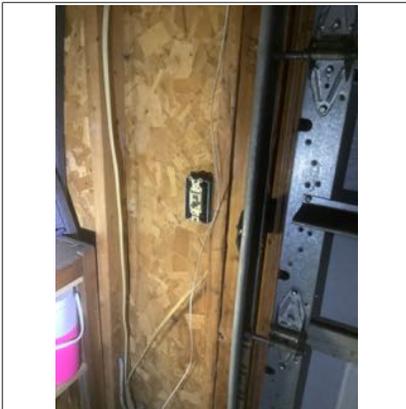
- There are multiple cover plate missing at receptacle and light switches. This is a safety concern. Recommend a licensed electrician install a cover plate.
- There are no GFCI's installed in the garage. This is a safety concern. Recommend a licensed electrician install GFCI receptacles.

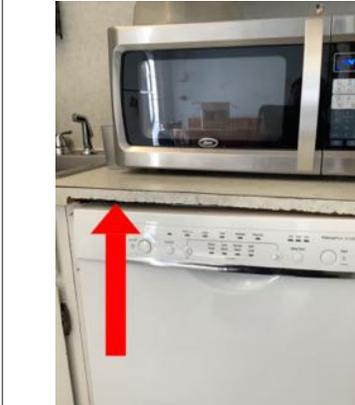
Damage countertops above dishwasher.

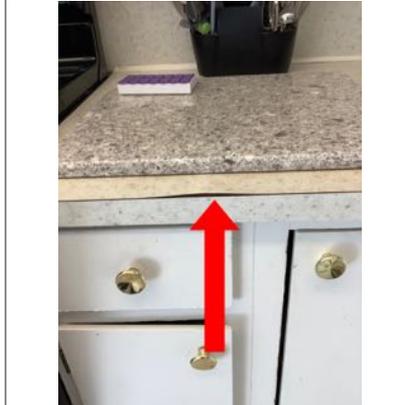
Countertops delaminating

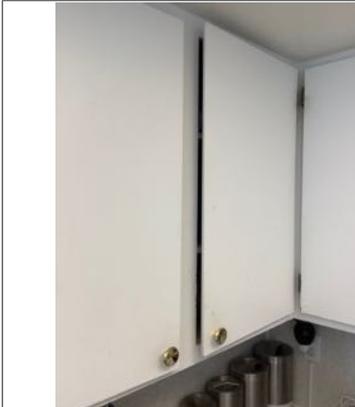
Comments The kitchen cabinet hinges are loose. Recommend hinges be tightened.

Cabinet door hinges needs adjustment/replace

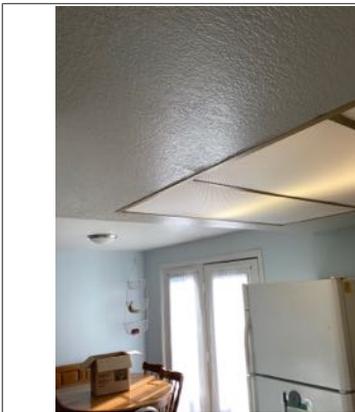
Cracks in lighting covers

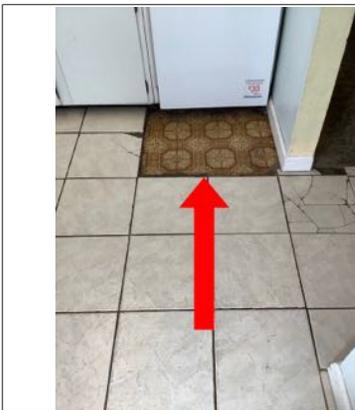
Comments The tile floor had some cracked tiles. Replace the tiles as needed. The floor covering in the kitchen is damaged, this is a trip hazard. Recommend repair/replace.

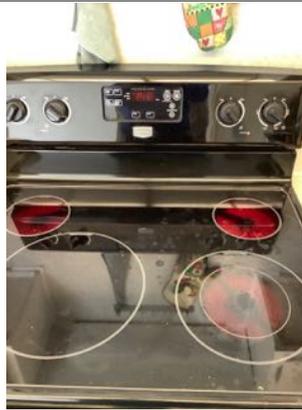
Comments **There is no tip guard installed at the oven. This is a safety concern. Recommend installing a tip guard.**

There is no tip guard installed at the oven. This is a safety concern. Recommend installing a tip guard

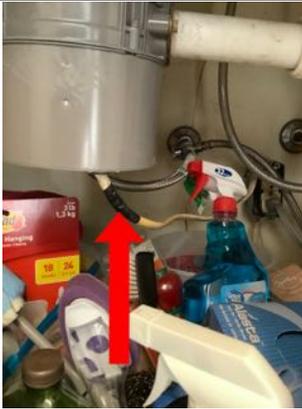
Damage to electrical wiring covered up with tape. Recommend license electrician repair/replace.

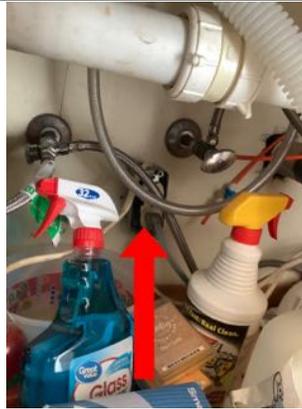
At least one cover plate is missing at a receptacle under the sink. This is a safety concern. Recommend installing cover plate. There are no GFCI receptacles installed in the kitchen. This is a safety concern. Recommend a licensed electrician install GFCI receptacles.

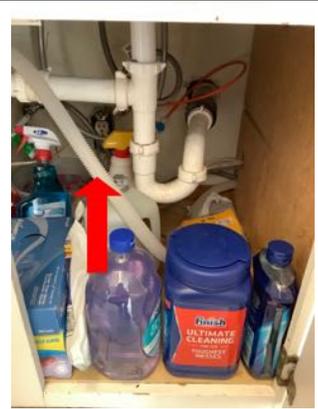
The dishwasher drain line is not looped beneath sink, recommend repair. Dishwasher was ran during inspection and with no findings.

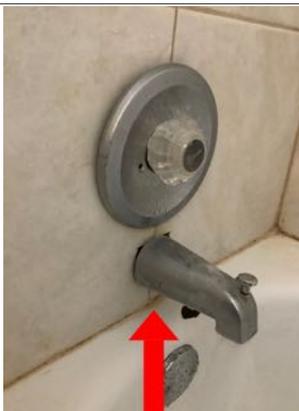
Recommend caulking/grouting in shower/tub area to help prevent damage from water penetration. The caulk/grout has dried and cracked. Recommend replacing the caulk/grout where needed.

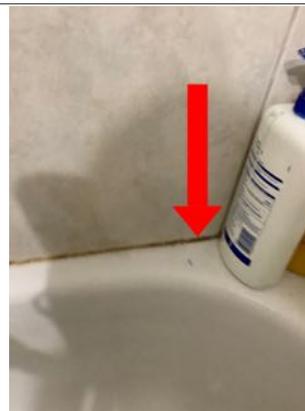
Recommend caulking/grouting in shower/tub area to help prevent damage from water penetration. The caulk/grout has dried and cracked. Recommend replacing the caulk/grout where needed.

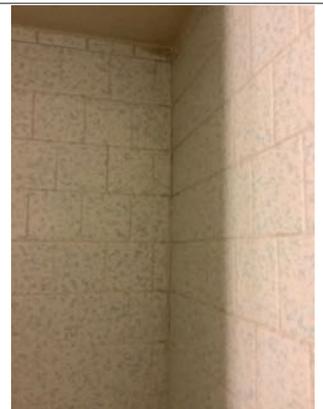
Recommend caulking/grouting in shower/tub area to help prevent damage from water penetration

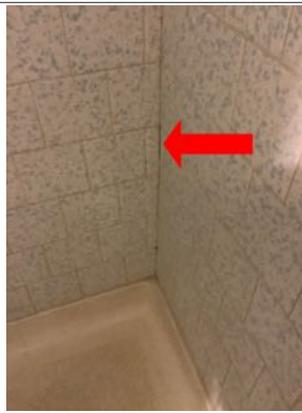
Recommend caulking/grouting in shower/tub area to help prevent damage from water penetration.

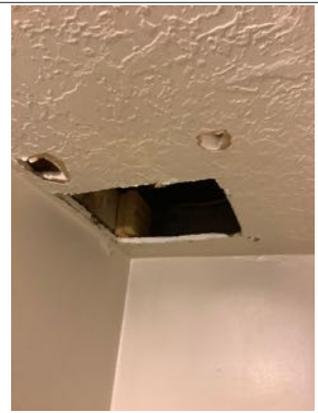
Moisture stains present, Moisture is not present. Recommend licensed contractor repair roof area

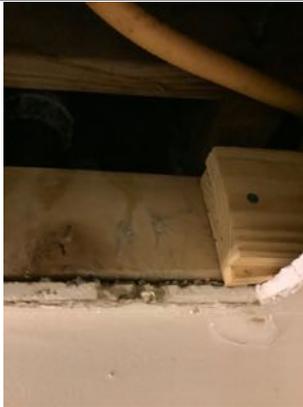
Moisture stains present, Moisture is not present. Recommend licensed contractor repair roof area

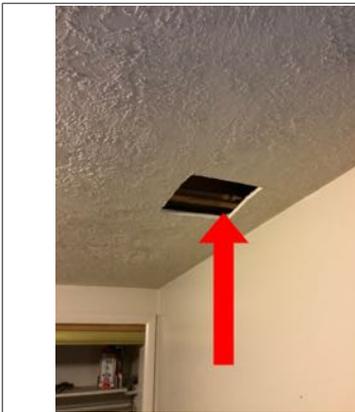
The outside hose bib line ruptured sometime in the past there is moisture stains present no moisture

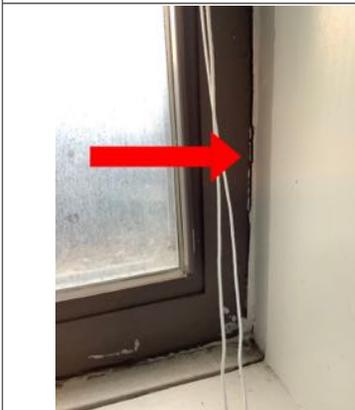
Caulk is dried out and missing recommend repair.

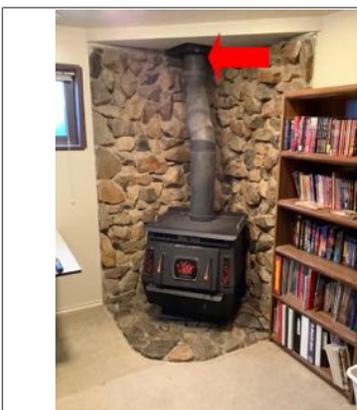
Evidence of rust recommend a Licensed roofer to examine the chimney.

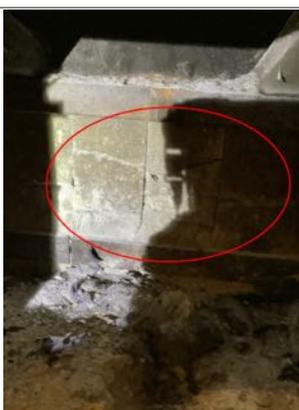
Fire brick has visible cracks recommend replace.

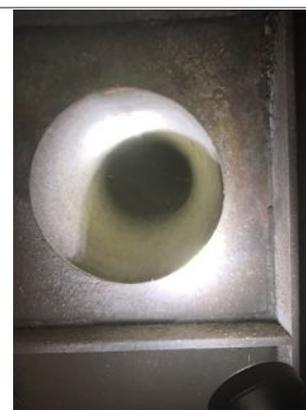
Note that the flue inspection is limited to only the visual portion of the flue. Recommend full flue inspection by a licensed chimney sweep prior to using the fireplace.

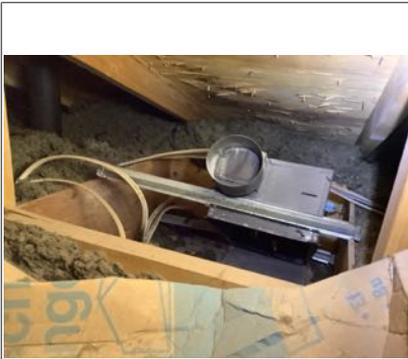
There are no vents in the bathroom and this is a vent for the bathroom that they sheet rocked over.

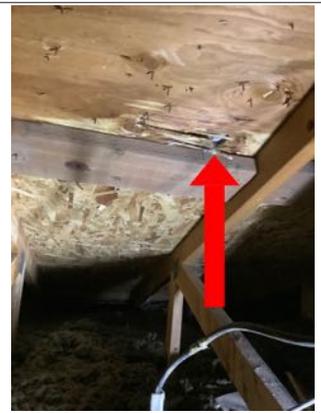
This is under the evaporated cooler. Moisture not present during time of inspections. There is evidence of staining. Recommend license roofer to evaluate.

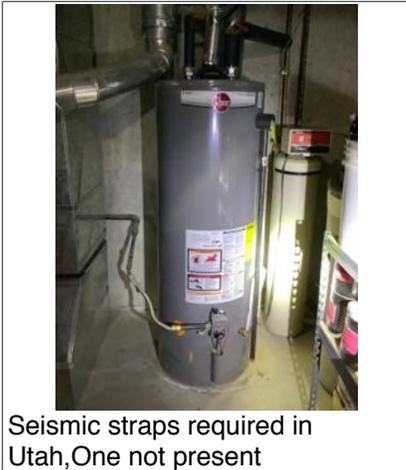
Seismic straps required in Utah, One not present

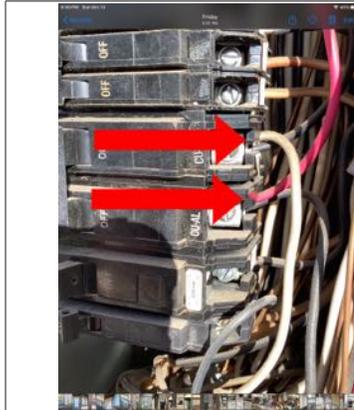
Double tapping is present. There are two breakers that currently are being double tapped. This is a safety hazard. Recommend a licensed electrician to evaluate.
